## Weekly Update

Aug 21 - 27

Devil's Slide (post mile 39.14)

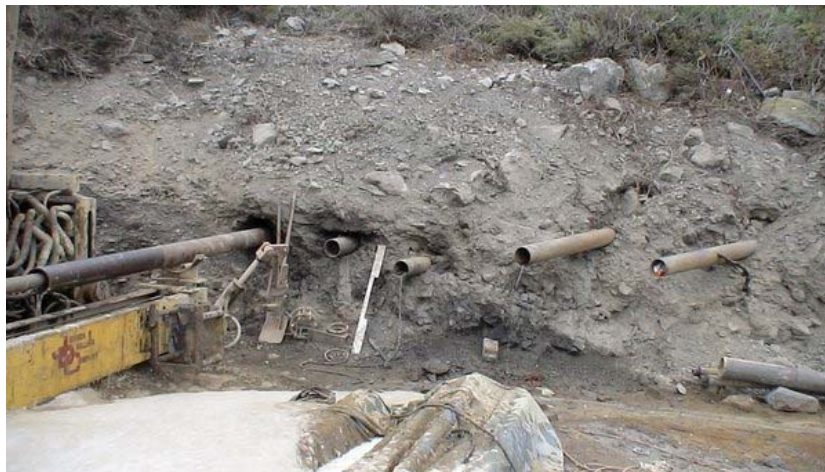
- Jensen Drilling continued drilling horizontal drains. All five drains are now complete.

All five horizontal drains

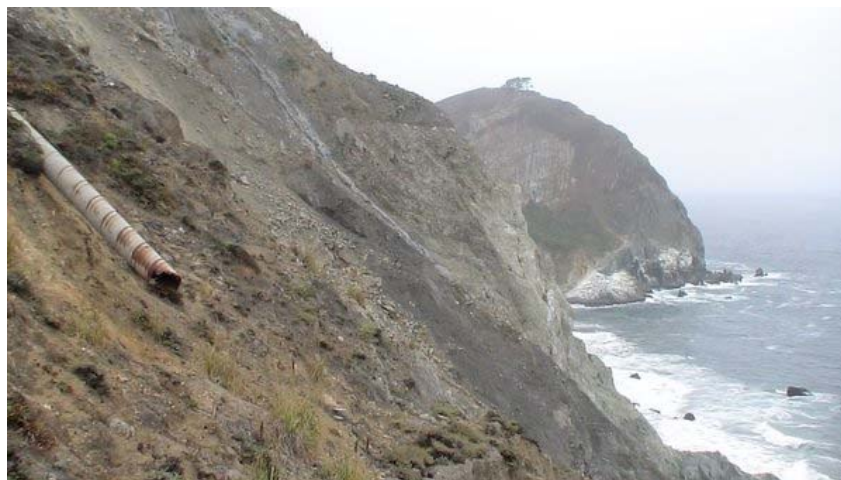
Vertical drain will be extended from this point

- Planning for the vertical drain pipe extension continued. Water from the pumping system and new horizontal drains will be directed to the vertical drain. The purpose of extending the drain is to prevent cliff erosion from this source.

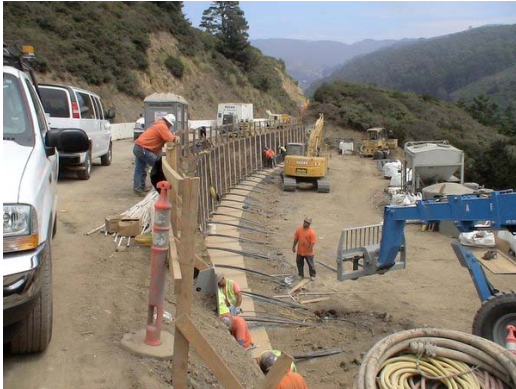
Overview of the retaining wall

- Rebar was installed for the waler wall and shotcrete applied at the end of the week. After 10 days the concrete will be strong enough for Condon & Johnson to begin stressing the tie backs.

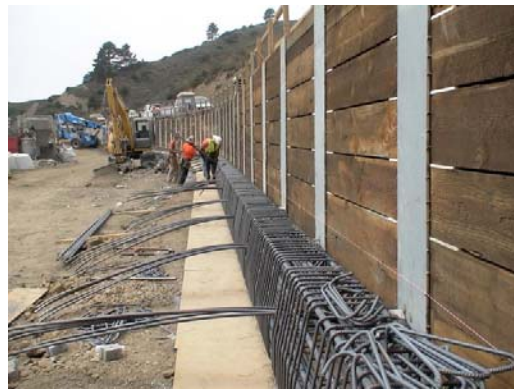
Rebar & tie back cables for the waler wall
